For the past 17 years GSB has partnered with our telecom customers in an effort to better understand the applications. These applications include wireline, wireless, renewable, and FTTx.

O GS	Study Sites	
	Wireline Applications -Milford CT -Addison, Texas -Chappell Hill, Texas Wireless Applications -Paris, OH -Tempe, AZ · Outside Air Cooled Cabinet · Outside Air Cooled Customer Premise	
January 2018	GSB CONFIDENTIAL	2

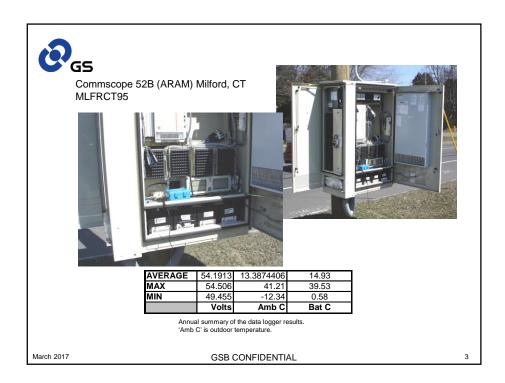
This string of PWL12V125FS was shipped in September 2006. We believe the string was installed between October 2006 and April 2007. The actual installation date is not known. **Therefore the time in service is between 9.70 to 10.24 years**.

The logger was removed in October 2014 following the sale of this franchise territory. During the course of that final site visit, we discovered the power system controller had again failed suspending temperature compensation for a period of time. It is not possible to determine the exact time period where temperature compensation was suspended at this site. It was at minimum 13 months based data retrieved from the data logger.

The new owner of this franchise returned the samples to GSB for testing in January 2017. There was no evidence of swelling, leaking or post seal failure. The samples were floated for 7 days and discharged at the 8 hour rate. **The string produced 133.7Ah or 107% of rated.** This is the oldest string recovered from a cabinet application by GSB.

A data logger was installed at the site in March 2008. At which time the power system controller settings were modified to enable low temperature compensation and begin high temperature compensation at 25°C instead of 35°C. In July 2008 a temperature probe was added to the power system controller and a outside temperature sensor added to the data logger. This power system was previously not equipped with a temperature probe.

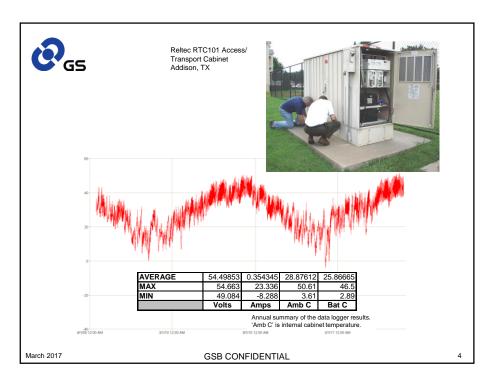
This structure and in particular this site was identified by the customer as a high temperature application where batteries had historically not performed well. This site and structure was selected by the customer as their most demanding application.

Outside air is drawn in on one end, forced through the electronics compartment and exhausts through the power and battery compartment. The Lorain A150CAB was not equipped with temperature compensation. However, a method had been devised using the boost feature to clamp float voltage when the batteries reached approximately 50C. Unfortunately some technicians would replace a rectifier and fail to 'reverse' adjust the boost setting and instead of clamping at 50C, the voltage would increase. This happened at least once during period our batteries were installed at this site.

The string located in the power compartment was removed from the site in March 2012 and the final 8 hour rate discharge was conducted. After 5.35 years in service the string produced 86% of rated capacity. We are highly confident, that if this site was equipped with a temperature compensated plant a seven year warranty threshold would have been met.

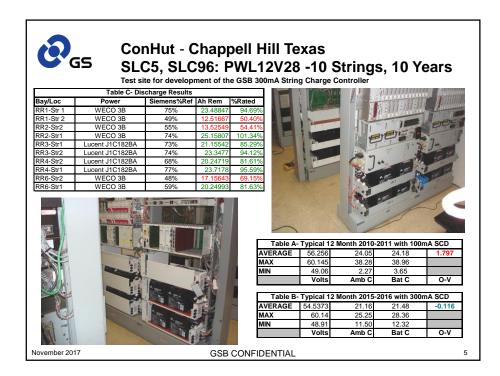
Forty (40) PWL12V28 were installed **December 11, 2007** in a wireline concrete hut in Chappell Hill near Brenham Texas. These were installed in a combination of SLC Series 5 (Lucent J1C182BA Power, Ringing Plant) and SLC96 (WECO 3B Battery Charger) Distributed Power RT Bays. A data logger was installed on RR1, String 2 to monitor float voltage, ambient and battery temperature. The structure was equipped with HVAC.

•This is one of several sites where the charging voltage presented by the J1C182BA or 3B Battery Charger could not be controlled by the 100mA version of the GSB SCD.

- Table A First 4 service years prior to development of 300mA SCD.
 - Severe overcharging with battery temperatures reaching 38C
- **Table B** Remaining 6 service years after installation of 300mA SCD.
 - Charge voltage controlled.

- Seven (7) strings were above 80% of rated after 10 years in service, <u>ranging 81.5% to 101.3%</u> of rated.
- Three (3) strings were below 80% of rated, ranging 50.4% to 69.15% of rated.

An experimental 300mA version of the SCD was deployed here for testing following the 4th service year.

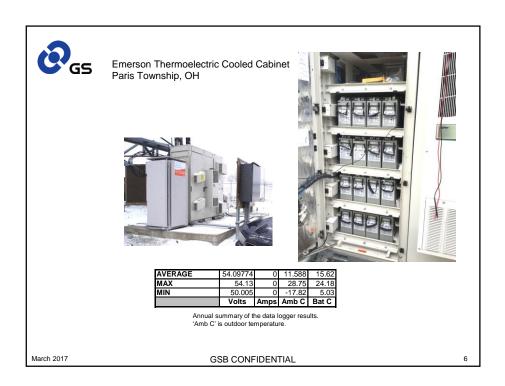
The TEC system at this site is the only reliable system of this type we have observed among the cabinets equipped with this type cooling. Temperature compensation is disabled and for a significant period the batteries were floated at 53.6V. The float has been increased to 54V but temperature compensation remains disabled. For the majority of the service life, these batteries have been floated below the recommended voltage and operated without temperature compensation.

At the request of the customer, we removed the string monitored by the logger and transported it to our lab. The string was discharged at the 8 hour rate. It produced **207.10Ah or 112% of rated capacity after 3.05 years in service**. The string was reinstalled and the study continues.

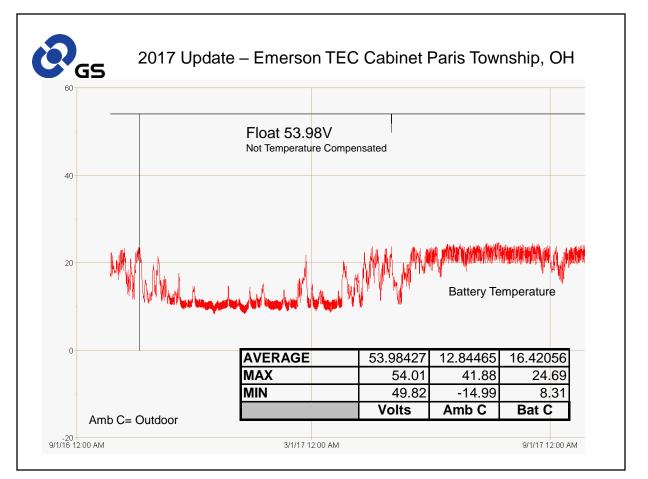
Logger Data October 1 2016 – September 30 2017:

The PYL12V185FT string reached **four (4) years in service September 2017**. A summary of the 12 month dataset Oct 2016 through Sep 2017 is shown here.

- •The average battery temperature for this period was 16.42C.
- •The average battery temperature July-September was 21.7C.
 - Maximum battery temperature during this period and for the period Oct-Sep was **24.69C.**
- •Analysis of battery temperature and float voltage:
 - •Temperature compensation is not active.
 - •Strings are equipped with temperature probes.
 - •The string is under charged during this period average ~630mV.
 - •Significant Undercharging 11-1-2016 to 3-31-2017
 - Average battery temperature 11.5C.
 - •The string was significantly under charged during this period at average 986mV.

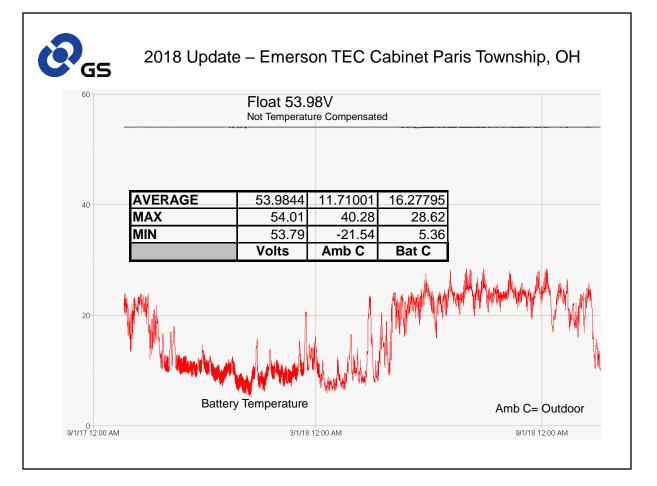
Logger Data October 1 2017 – September 30 2018:

The PYL12V185FT string reached **five (5) years in service September 2018**. A summary of the 12 month dataset Oct 2017 through Sept 2018 is shown here.

- The average battery temperature for this period was 16.27C.
- •The average battery temperature July-September was 23.46C.
 - Maximum battery temperature during this period and for the period Oct-Sep was **28.62C.**
 - •The TEC appears to be less effective as compared to prior years.
- •Analysis of battery temperature and float voltage:
 - •Temperature compensation is not active.
 - Strings are equipped with temperature probes.
 - •The string is under charged during this period average 644mV.
 - •Significant Undercharging 11-1-2017 to 3-31-2018
 - •Average battery temperature 9.95C.
 - •The string was under charged during this period at average 1.099V.

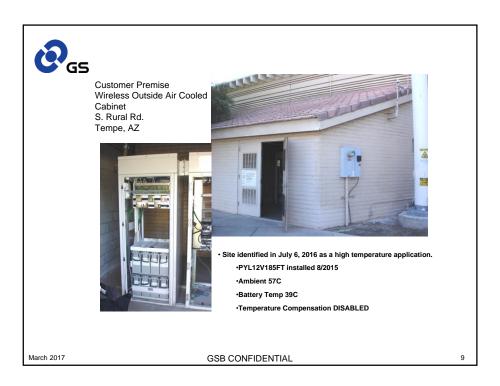
The customer identified this site as an 'outside air cooled' high temperature application. Two strings were removed from this site at the end of the summer in November 2016 for testing. They were taken to the customer's facility and discharged at the 8 hour rate. A data logger will be installed at this site in 2Q2017.

After 1.29 years in service under these conditions the strings produced 110% and 103% of rated capacity. The next test was performed in November 2017 in association with other long term life studies under way in Arizona.

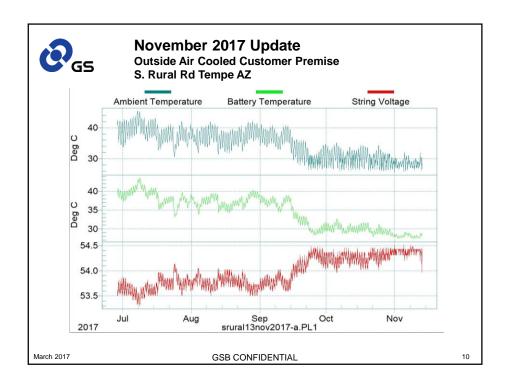
Logger Data June 2017-November 2017:

- The average battery temperature during this period June November 2017 was 34.39C and the average float 53.96V.
- During the period June 28 through September 28 the average battery temperature was 36.85C and the average float 53.80V.

- The two strings were removed for testing the week of November 13, 2017.
- After 2.29 years in service these strings produced **108% and 109.5%(1) of rated** capacity.

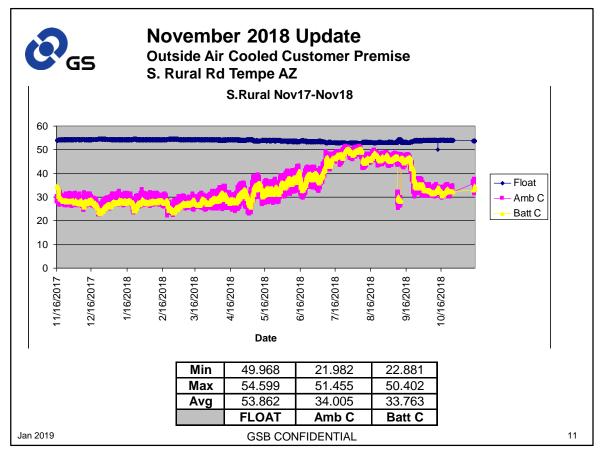
Logger Data November 2017-November 2018:

- The average battery temperature during this period Nov 2017 Nov 2018 was **33.76C** and the average float 53.86V.
- Maximum battery temperature was **50.4C**.
- Temperature compensation during this period was accurate.
- During the period June 1 through September 30 the average battery temperature was **42.69C**.
- The data logger was removed in January 2019.
- These strings were not discharged at this time.
 - They are to be removed to measure capacity in August 2019 after they have reached 4 years in service.

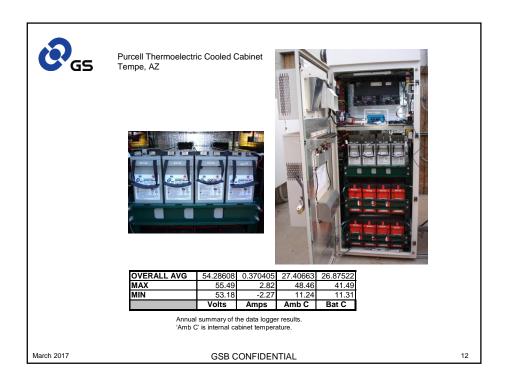
It is important to note that the TEC system in this cabinet is plagued with frequent failures sometimes lasting for 30-90 days. This wireless service provider is in the process of eliminating TEC due to reliability issues. The maximum temperature occurs when TEC has failed. However, temperature compensation is operational and the float is well managed thus mitigating the effects of high temperature operation when the TEC is not functioning.

The string was removed May 2016 and discharged at the 8 hour rate at the customer's facility in Tempe. It produced 202.45Ah or 109.6% of rated capacity after 2.65 years in service. The string was reinstalled and the study continues.

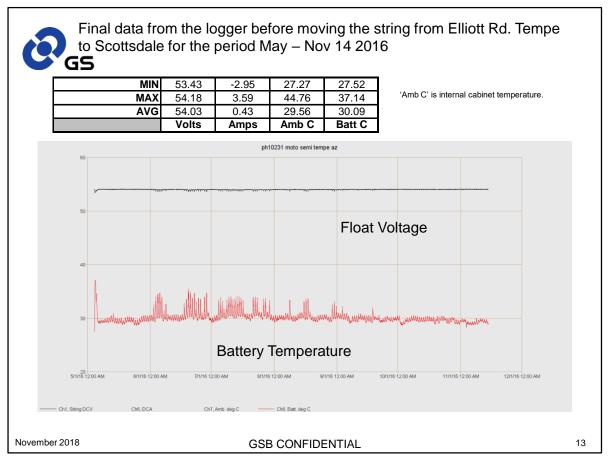
November 2016

The Elliott Rd (Tempe) cabinet has experienced reliability issues with the TEC for the duration of this study. The cabinet was identified as a candidate to be converted to air-cooled and eliminate the troublesome TEC at this site.

The final dataset from this logger prior to relocating the string to Casino Arizona-Scottsdale is shown. Although it appears the TEC was functioning during the summer months it was out of service when we visited the cabinet in November 2016.

In order to continue aging these PYL12V185FT samples in a TEC cabinet application, the samples were relocated to 524 N. 92nd St. Scottsdale (Casino Arizona lot).

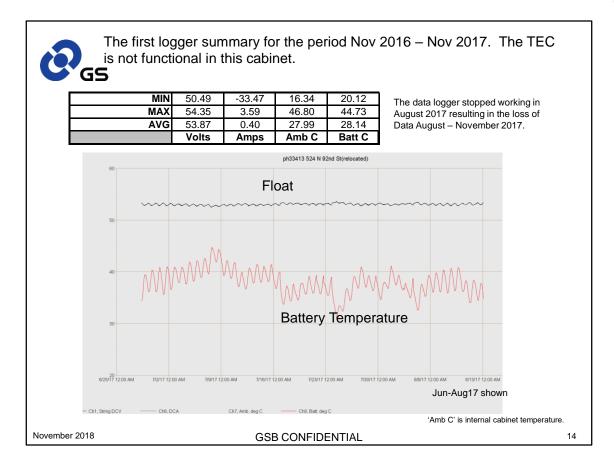
November 2017

The samples have spent a full year in the TEC cabinet at Casino Arizona in Scottsdale. This cabinet is identical to the Purcell cabinet at Elliott Rd. The TEC was not working when we installed the samples at this site in November 2016.

The data logger stopped recording in August 2017. Data from mid-Aug-Nov 2017 is missing.

Notice the maximum battery temperature is 44.7C with the non-functional TEC and period average is 28.1C. Substantially higher than experienced in the Elliott Rd TEC cabinet. The average would likely have been higher if this dataset included through mid-October.

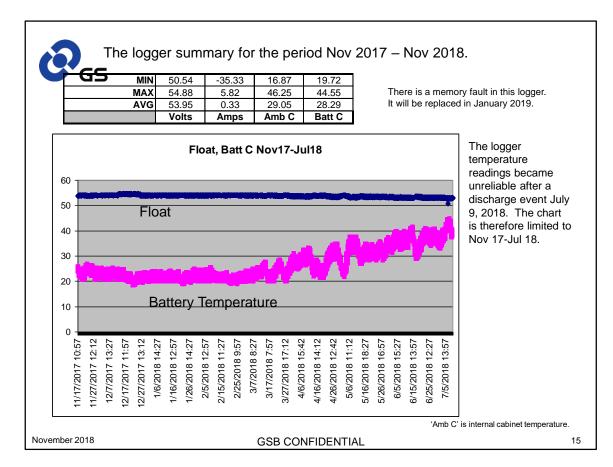
These PYL12V185FT samples have spent two years in the TEC cabinet at Casino Arizona, November 2016 through November 2018. The TEC remains non-functional. Some leads have been disconnected and appear to have burned.

Data recovered from this logger is once again been corrupted. There appears to have been a lightning or power event about July 9, 2018 at 17:12. The logger recorded a discharge event (50.55V) and at the same time battery temperature dropped from 40.07C to 24.28C. Internal cabinet temperature also dropped from 41.38C to 26.44C in 15 minutes. All subsequent temperature readings after July 9, 2018 appear to be inaccurate. This event may be related to the burned TEC leads. I suspect the average battery temperature November 17- Jul 9, 2018 is accurate, **averaging 38.28C**. This event may also have caused the data corruption. The logger is no longer reliable and will be replaced in January 2019.

The maximum battery temperature at **44.55C** is similar to that observed between Nov16-Nov17. The average battery temperature of **28.29C** for this period Nov17-Nov18 is unreliable given the event mentioned above.

The string was removed November 2018 and discharged at the 8 hour rate. It produced 177.27Ah or 95.93% of rated capacity after 5.22 years in service. Being satisfied with the results the customer elected to conclude the study at this time. The samples have been returned to the factory for tear-down and analysis.

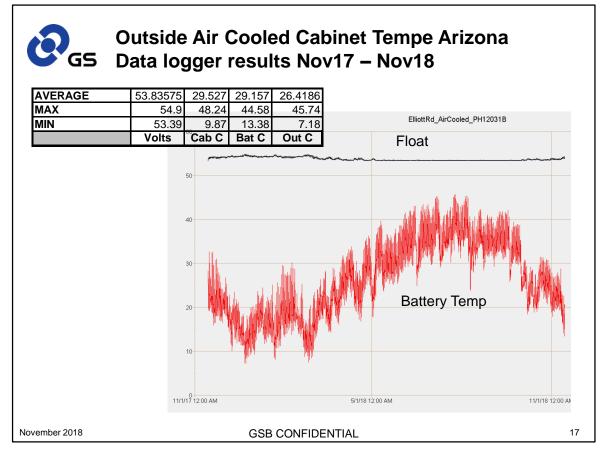
Logger Data November 2017 – November 2018:

- The average **battery temperature for this period was 29.15C**, slightly higher than the average outdoor temperature of **26.41C**.
 - Similar to Nov 2016-Nov 2017.

- The July-September average battery temperature was **35.9C**.
 - Maximum battery temperature was 44.58C
- Analysis of battery temperature and float voltage:

- High-Temp-Comp is maintaining the float within the battery operating range.
 - Low-Temp-Comp at times is under-charging ~200mV. This should not affect battery life but may be an indication of an incorrect temperature compensation setting in the plant.

- Being satisfied with the accumulated data for this site, the customer requested the data logger be removed in January 2019.
- During the summer months, fans do not appear to operate when the outside air is cooler during pre-dawn hours. This is a missed opportunity to lower the temperature of the thermal mass (batteries).
